DEAP Methodology Update

Onsite defaults for upgraded existing dwellings

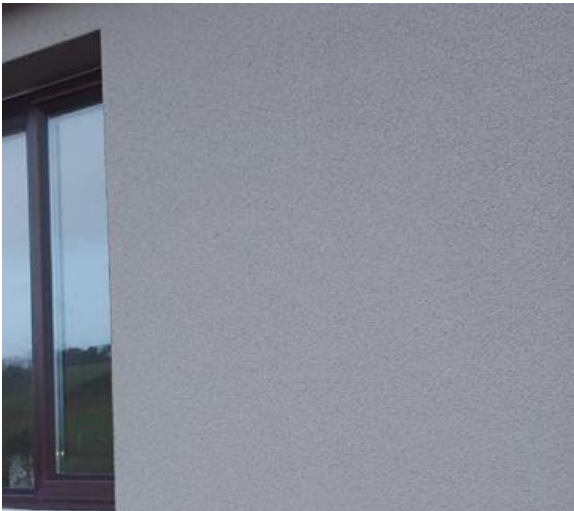
Figure 1 – EWI render with 1.5mm grain

Acrylic/silicone render is essentially a mixture of paint and sand. The size of the grain varies from 0.5/1mm to 3.5/4mm, but the most common grain size is 1.5mm. On the wall, the render finish will have a textured, grained finish, which makes it distinguishable from a standard sand & cement render which will tend to be smoother.

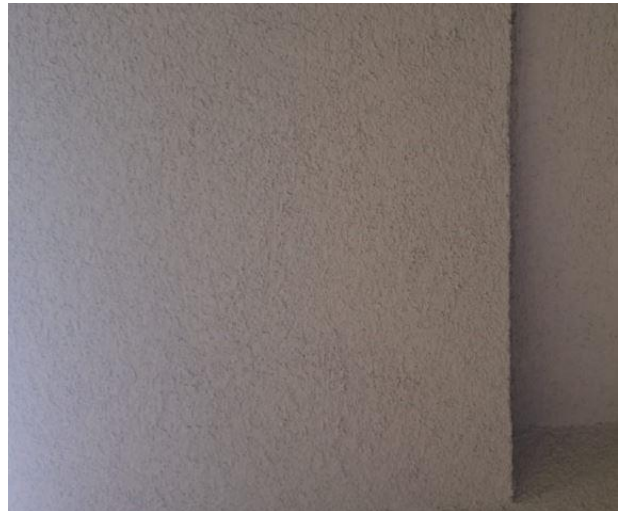
Figure 2 – EWI render with 3mm grain

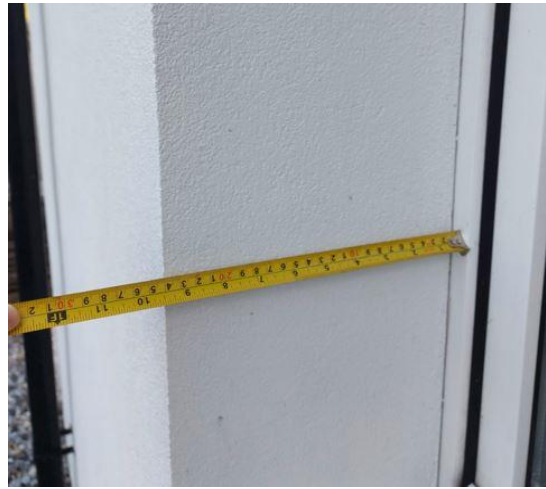
Figure 3 – Larger exterior reveal depth (240mm)

In a standard masonry wall – no external insulation added - the external reveal depth will typically be less than 150mm. When external insulation is retrofitted to the exterior walls of a dwelling, in many cases the windows are not moved. Therefore, the post-works external reveal depths will tend to be larger – typically greater than 200mm.

Therefore, a larger than usual external reveal-depth may indicate the presence of external insulation. However, this does not always apply, in some retrofit projects, the windows will be moved outward to sit in line with the external insulation layer, in which case the external reveals will be of a standard depth.

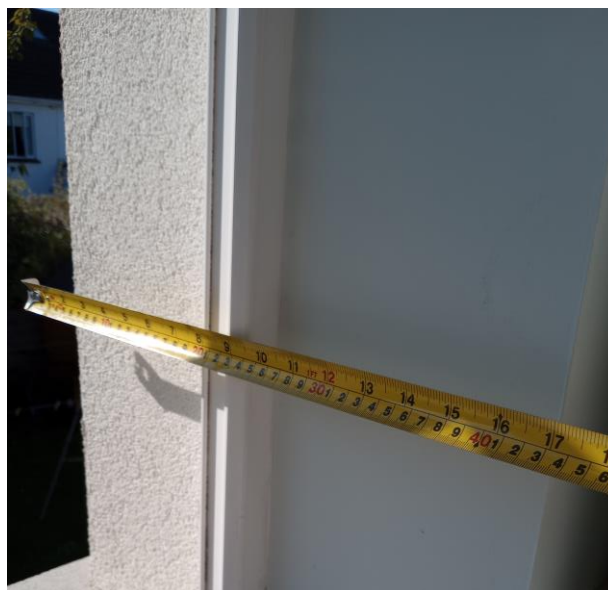
Figure 4 – Wall thickness as a verification indicator

In the example in Figure 4, a thickness of over 400 mm can be expected when external insulation has been applied to a hollow block wall that was initially built with 50 mm of internal insulation (Age band H).

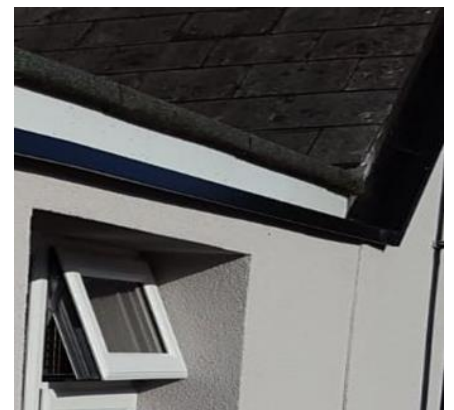
Figure 5 - Metal flashing at soffit level

In retrofit scenarios, it is common to find that existing barges and soffits on a dwelling may not have the required depth to accommodate the thickness of insulation, installed. This could compromise the waterproofing of the insulation. To counter this, flashings can be attached to the underside of the barges and soffits to extend out over the insulation and allow any water to drop to the ground. These flashings are usually made of powder-coated aluminium.

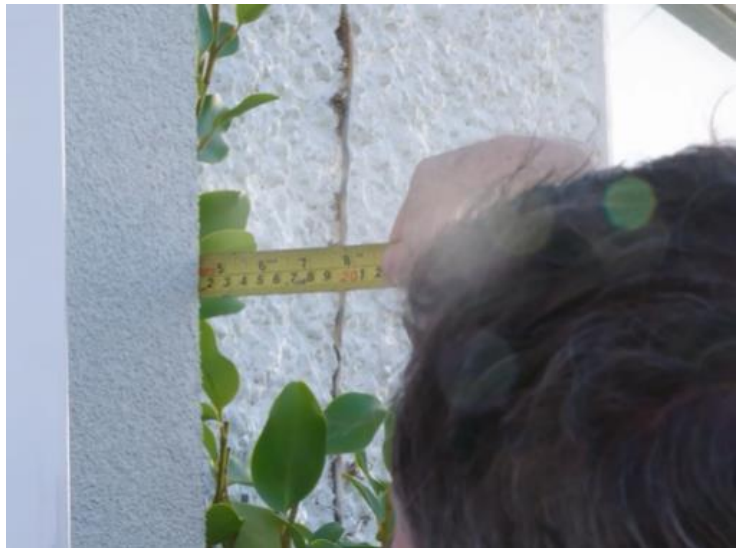
Figure 7 - EWI upgrade evidence at boundary wall

Another opportunity to verify EWI is the boundary between two houses where the other house hasn't installed EWI, shown in Figure 7. As the insulation can be measured onsite in this instance, use the onsite *measurable* verification route to confirm the EWI upgrade.

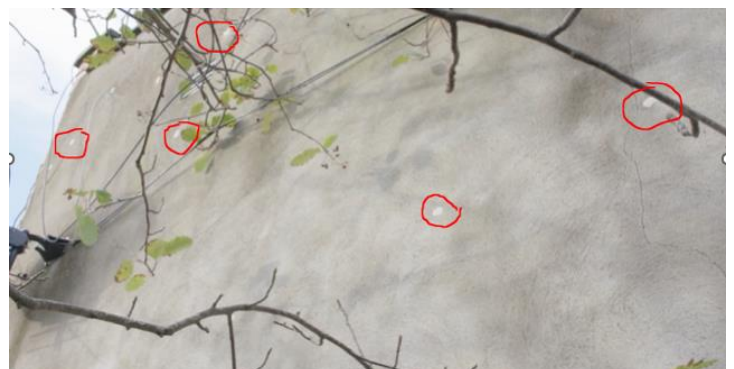
Figure 9 - Drill pattern example for CWI upgrades

One of the main indicators for the presence of CWI is the drill pattern on the exterior of external walls. Drill marks should be spread out across larger wall sections and especially around windows where the flow of the beads may be restricted by the window hence requiring more holes for a better installation. These marks are typically filled with mortar. If using the presence of these marks as evidence of cavity wall fill insulation, they must be visible on each facade for which the filled cavity wall U-value is to be applied.
