Home Energy Grants: Technical Bulletin – Heat Pump Systems

Documentation Handling and Water Pipework Guidance

Series 2024-04-001

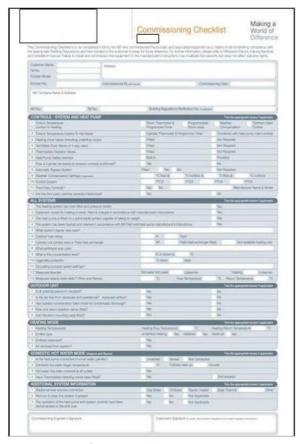
Figure 1: Commission Cert

The most frequent documents which are absent upon an inspection, and subsequently cause reworks, are the **Commissioning Documents and Register of Electrical Contractors Ireland (RECI) Cert.** As an appointed Contractor for a grant aided heat pump system installation, it is your responsibility that all necessary pieces of documentation are handed over to the Homeowner prior to signing the Declaration of Works (DOW) forms.

- 1. Leave Physical Copy of Necessary Documentation: Firstly, the Contractor should leave a physical copy of all necessary documents (as mentioned above) with the Homeowner and inform the Homeowner that they may be subject to a pre-pay or post-pay inspection from SEAI. Should that particular Homeowner be randomly selected for inspection, they will have to produce this documentation upon request from the Inspector. Please note, failure to produce this documentation may result in delay in payment of the grant or loss of the grant money entirely should the Contractor fail to complete necessary reworks.

- 2. Email a copy of Documentation to Homeowner with the subject line "HEAT PUMP DOCUMENTS FOR SEAI INSPECTION": An email with the necessary documentation attached with the above subject line ensures that even if the Homeowner misplaces the physical copy of the documents, there is a backup copy of the documents on an email which is easily searchable with the above subject line.

- 3. Take a Picture of the necessary documents and send to Homeowner via WhatsApp: The SEAI Inspector just needs to see proof that these documents were transferred from the Contractor to the Homeowner and the Homeowner has access to them. A fast and easy way to prove this to an SEAI Inspector is for the Contractor to take a picture of these documents and send them to the Homeowner via WhatsApp. The Contractor must, again, inform the Homeowner that upon inspection they can show the picture of the documents received from the Contractor via WhatsApp.

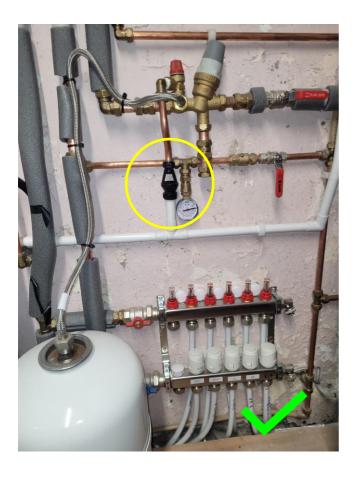
Figure 3: Example of correct installation of tundish on PRV

No tundish installed on the safety pipework leading from the Pressure Relief Valve therefore there is no apparent outlet for Homeowners to observe any discharge from the safety valve.

Install a tundish to the internal pipework leading from the Pressure Relief Valve so there is a visibility point for the Homeowners to observe any discharge

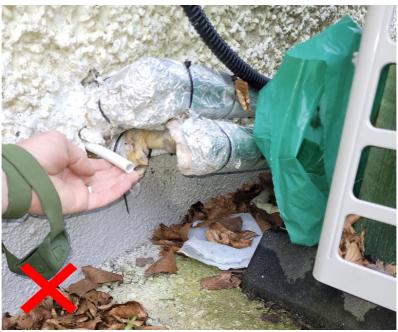
Figure 4: Incorrect Installation

Pressure Relief Valve Pipework not terminating safely at point of termination outside (plastic discharge pipe)

Ensure Pressure Relief Pipework terminates through exterior of building through metal discharge pipework and to a safe and visible area

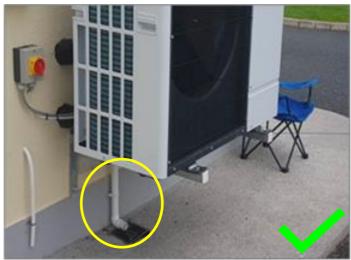
Figure 7: Correct Installation

Condensate water from external heat pump unit discharging onto the surface underneath the unit. No drain access provided.

A correctly plumbed drain is required from the heat pump system for disposal of condensate and potential discharge from the safety valves' tundish
