# Home Energy Grants: Technical Bulletin

## Heat Pump System Installation Guidance

Series 2021-08-001 HP

# Correct installation guidance for heat pump

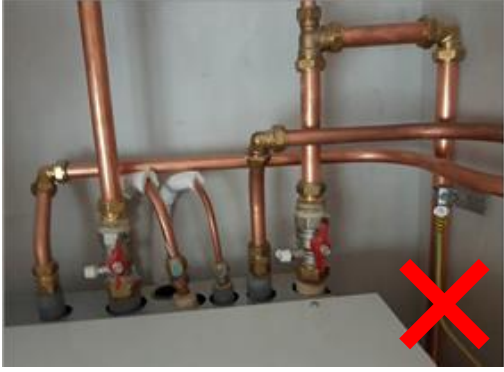
<p>Figure 1: Incorrect Installation</p>

<p>Figure 2: Correct Installation</p>
<p>Incorrect Method:</p> <ul style="list-style-type: none"> <li>- No ground wire connection in each metal pipeline.</li> </ul>	<p>Correct Method:</p> <ul style="list-style-type: none"> <li>- All metal pipes are bonded together via 10mm<sup>2</sup> ground wire with ground coupling.</li> </ul>

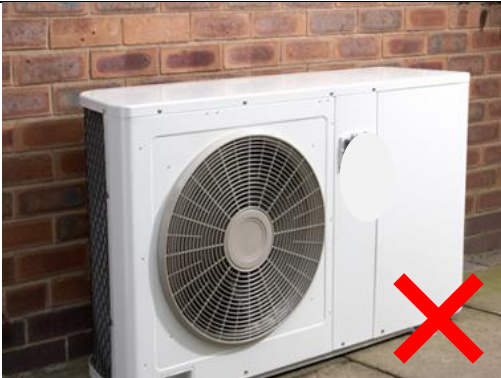
<p>Figure 3: Incorrect Installation</p>

<p>Figure 4: Correct Installation</p>
<p>Incorrect Method:</p> <ul style="list-style-type: none"> <li>- No isolation switch installed.</li> </ul>	<p>Correct Method:</p> <ul style="list-style-type: none"> <li>- Heat pump must be fitted with isolation switch near the unit and properly rated.</li> </ul>

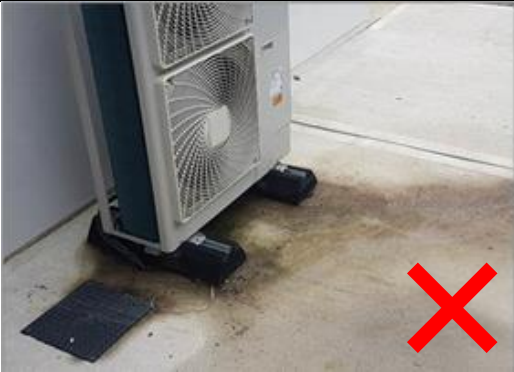
<p>Figure 5: Incorrect Installation</p>

<p>Figure 6: Correct Installation</p>
<p>Incorrect Method:</p> <ul style="list-style-type: none"> <li>- Condensate water from external heat pump unit discharging directly onto the surface underneath the unit. No drain access provided.</li> </ul>	<p>Correct Method:</p> <ul style="list-style-type: none"> <li>- The external heat pump unit has been fitted with a PVC pipe to allow condensate water discharge directly to drainage system.</li> </ul>

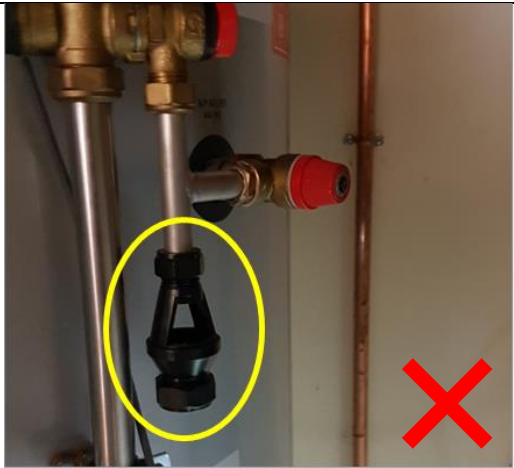
<p>Figure 7: Incomplete Installation</p>

<p>Figure 8: Correct Installation</p>
<p>Incorrect Method:</p> <ul style="list-style-type: none"> <li>- Pressure relief valve has no pipe connection for discharge to building exterior.</li> </ul>	<p>Correct Method:</p> <ul style="list-style-type: none"> <li>- Has pipe connection to building exterior using proper fitting and good plumbing practice.</li> </ul>

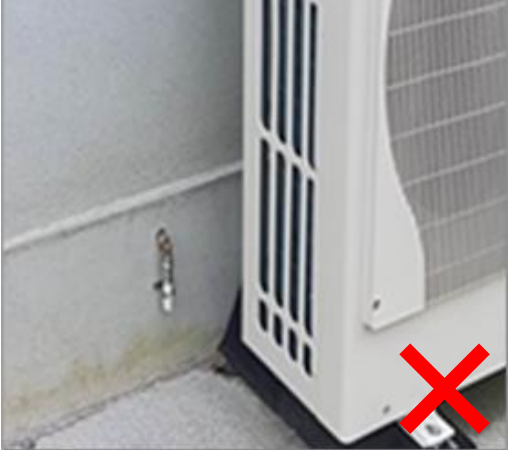
<p>Figure 9: Incorrect Installation</p>

<p>Figure 10: Correct Installation</p>
<p>Incorrect Method:</p> <ul style="list-style-type: none"> <li>- <b>Plastic</b> discharge pipe through building exterior.</li> </ul>	<p>Correct Method:</p> <ul style="list-style-type: none"> <li>- <b>Metal</b> discharge pipe through building exterior.</li> </ul>
