13 Cultural heritage

13.1 Introduction

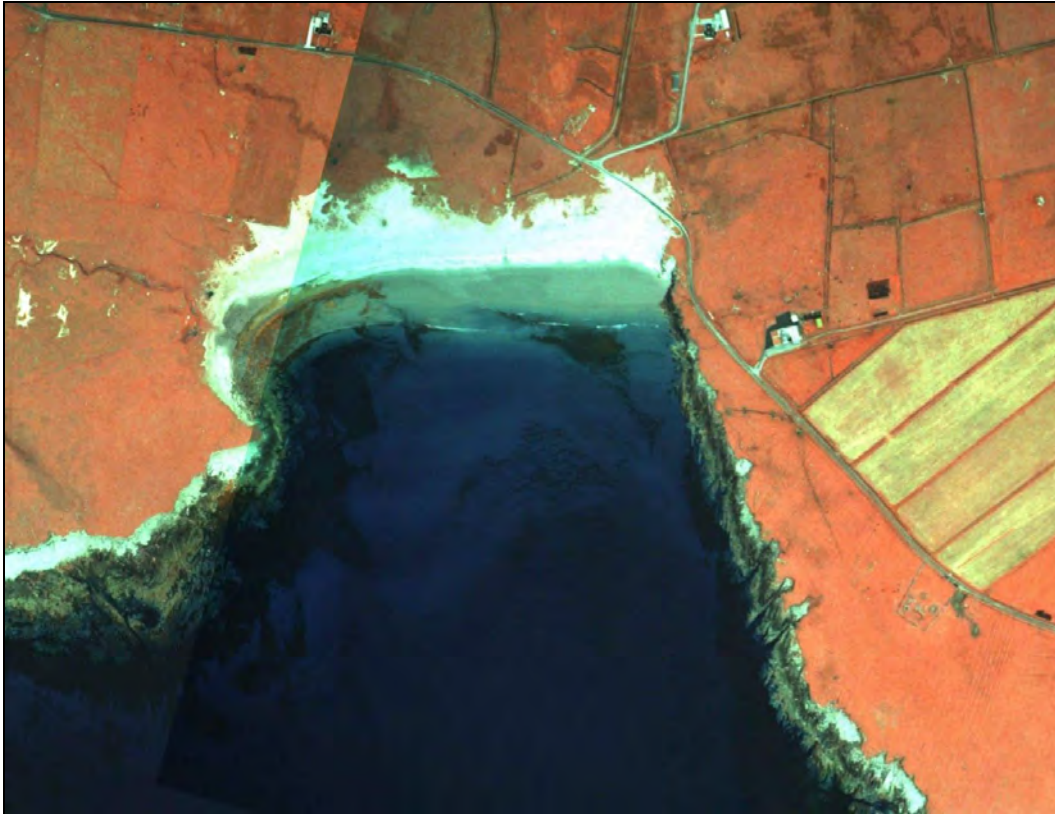
Photo 13.1: Aerial image of Belderra Strand and adjacent shallow waters

The aerial image in Photo 13.1, captured in 1999, shows a new road built across the foreshore. The area on the land side of the road is now filled in, possibly by windblown sand, and a small car park has been constructed adjacent to the road on the Belderra Strand side of the road.

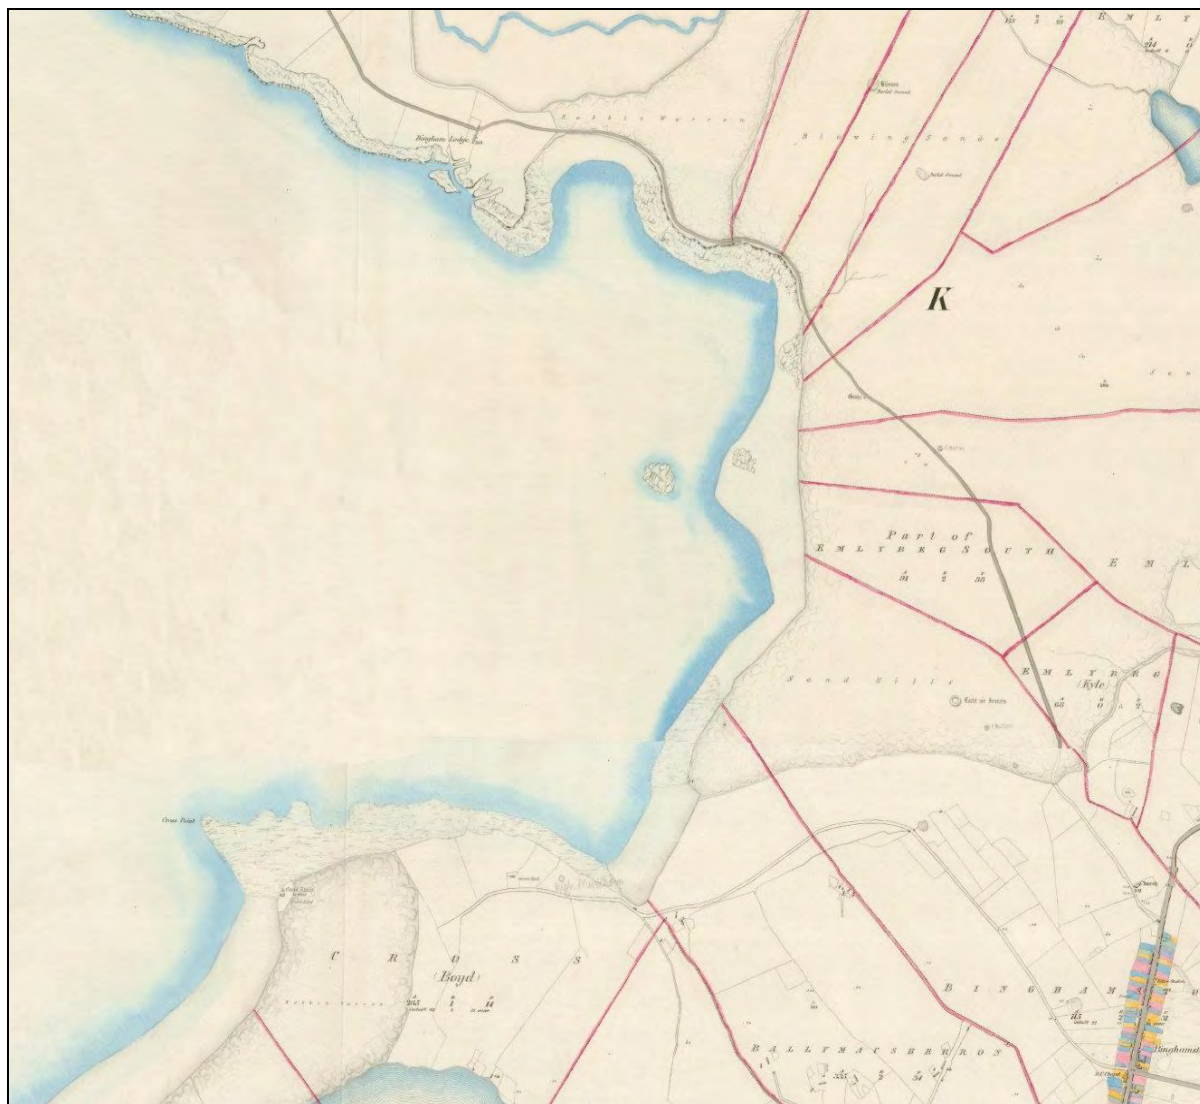
Figure 13-4: Extract from the first edition Ordnance Survey map of County Mayo (1838)

The first edition Ordnance Survey map for County Mayo, Sheets MA 09 and 016, surveyed in 1838, is not very descriptive of the landfall site and is of limited benefit in identifying possible cultural heritage (Figure 13-4). The first edition map shows the beach access road in its current location, but secondary access roads appear to have changed. The access road which travels through west Cross townland previously started further west than currently. Cartographic evidence would appear to indicate that field boundary extensions and drainage works have now claimed this area, resulting in a distinct northerly diversion in the road route.

A second roadway that runs along the boundary between Cross and Ballymacsherron townlands is not shown on the 1838 map, and is clearly a later creation. A number of structures, including a rectangular house-type structure and smaller outhouses, are depicted on the map close to the location of the substation. These are absent from all subsequent maps and no trace of them can be seen on the site.
